In-Situ Network

Palm tree branches for coastal protection, Tarawa Atoll, Kiribati

Main author
Maj Plemenitas, architect, LINKscale, London, UK

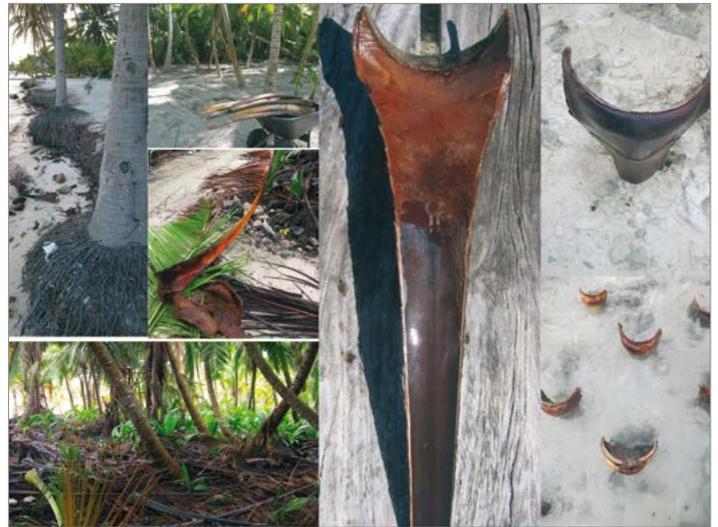
Image 1: Palm tree branch as construction material for coastal protection.

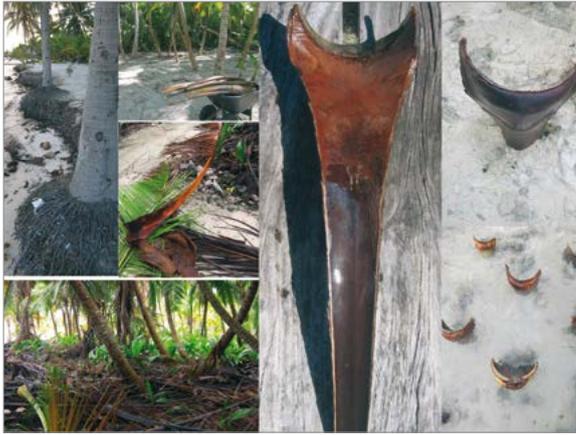
Image 5: Photos from construction site, where building material is usually seen as a waste material.

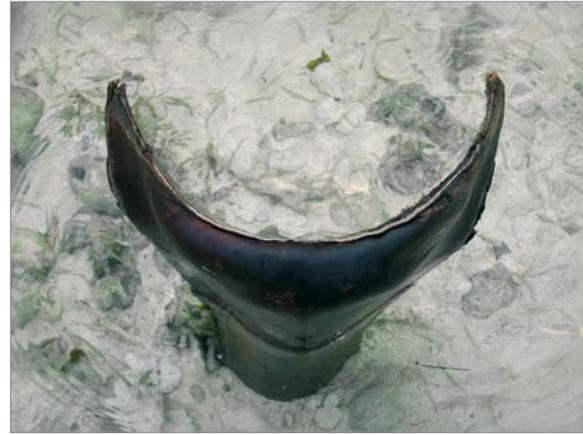
Image 6: Main "spoon-shaped" unit in the network.
